# Manhole Inspection Summary

Manhole # S29II1025MH

Insp Date: **2/5/07 12:28 PM**

**Location** Address: **703 UNIVERSITY PKWY**

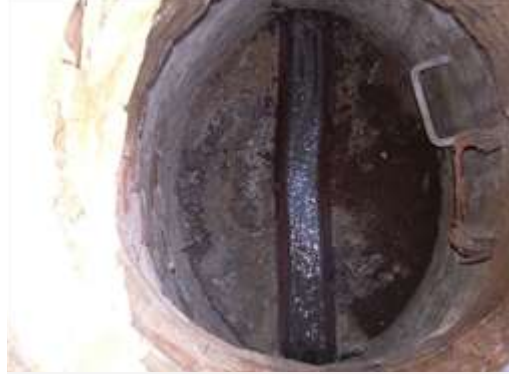
Top View

**Bench** ☒ Exists Material: **Brick** ☐ Parged ☒ **Debris** (not Condition related)

**Steps** Count: **2** Missing: **0** ☒ **Corroded**

Corroded steps. Bench debris.

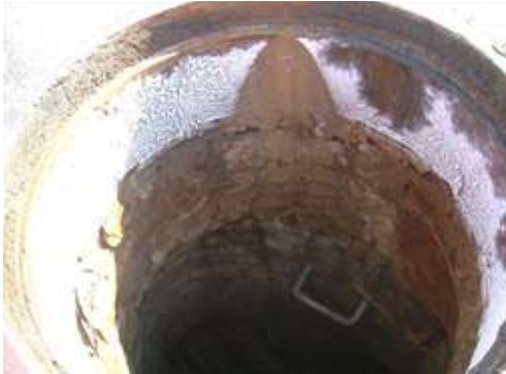
Defect

**Frame** Offset: **0** (in.) Condition: ☐ Sound ☐ Cracked ☒ **Leaks**

Condition: ☐ Sound ☐ Cracked ☐ Root Intrusion ☒ **Loose Brick** ☒ **Deteriorated**

Infiltration: ☐ None ☒ **Joint** ☐ Cracks ☒ **Mortar** ☐ Roots ☐ Wall

Infiltration: ☐ None ☐ Joint ☐ Cracks ☒ **Mortar** ☐ Roots ☒ **Wall**

Frame leaks. Adjustment deterioration, loose brick and infiltration. Corbel and Barrel infiltration.

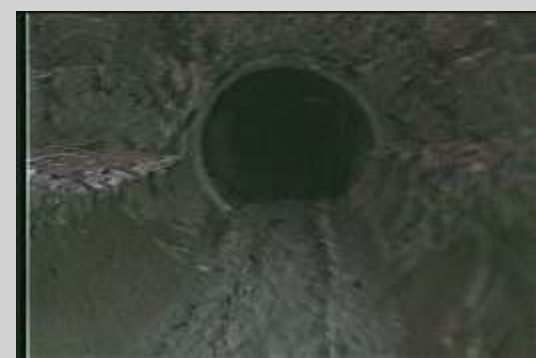
### 8 in. Circular Gravity Sewer Pipe Out @ 12 O'Clock

Infiltration: **Evidence** Pipe Seal Cond: **Unknown**

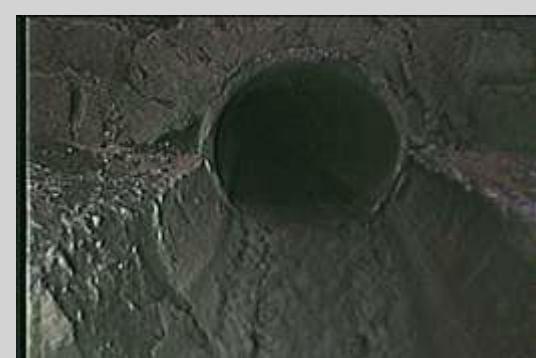
### 8 in. Circular Gravity Sewer Pipe In @ 6 O'Clock

Infiltration: **Evidence** Pipe Seal Cond: **Cracked**
